# Hillside Terrace: (Multiple Units)

## NSPIRE Inspection

Scheduled: 08/10/2023

ID: 456959

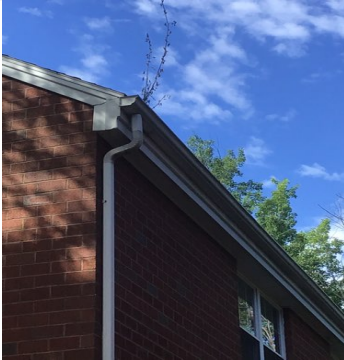
Location	Item	Results	Notes	Pic	Date	Fixed	Sev	HUD Pts	Adj Pts	Fix By
Rear of Building	Roof Drain/Ponding	Debris is limiting the ability of water to drain		1	08/14/23 09:34 TK		Mod	0.24	0.10	30D

Building A - Rear of Building - Roof Drain/Ponding - Aug 14 2023 9:34AM - T Knight

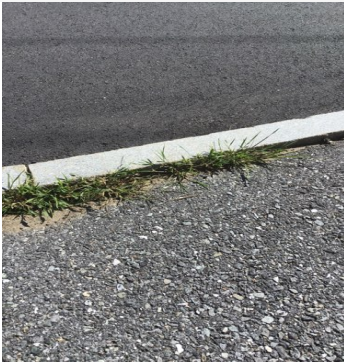
Location	Item	Results	Notes	Pic	Date	Fixed	Sev	HUD Pts	Adj Pts	Fix By
Front of Building	Tripping Hazard	Tripping hazard - 3/4in. vertical difference	Outside unit 45	2	08/31/23 10:35 TK		Mod	0.24	0.10	30D

Building F - Front of Building - Tripping Hazard - Aug 31 2023 10:35AM - T Knight  
CAPTION: Outside unit 45

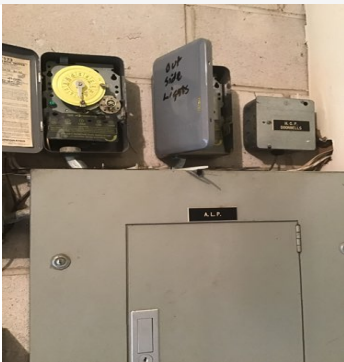
Location	Item	Results	Notes	Pic	Date	Fixed	Sev	HUD Pts	Adj Pts	Fix By
Local Systems (Bldg)	Lighting – Auxiliary	Auxiliary lighting component fails to illuminate when tested			08/14/23 09:04 TK		Severe	0.71	0.30	24H
Mechanical/Utility Room	Conductors, Outlets, Switches	Electrical conductor is not properly insulated/enclosed		3	08/14/23 09:08 TK		LT	2.87	1.21	24H

Building A - Mechanical/Utility Room - Conductors, Outlets, Switches - Aug 14 2023 9:08AM - T Knight

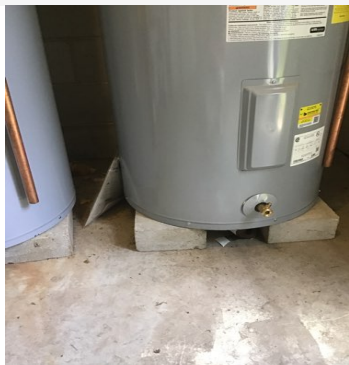
Location	Item	Results	Notes	Pic	Date	Fixed	Sev	HUD Pts	Adj Pts	Fix By
Hallways & Corridors (Bldg)	Conductors, Outlets, Switches	Electric outlet inoperable (no visible damage)	Interior stairs to second floor between 9 and 11		08/14/23 10:28 TK		Severe	0.71	0.30	24H
Mechanical/Utility Room	Water Heater	Pressure relief valve terminates higher than 6in. or less than 2in. from the floor		4	08/14/23 11:17 TK		Mod	0.26	0.11	30D

Building B - Mechanical/Utility Room - Water Heater - Aug 14 2023 11:17AM - T Knight

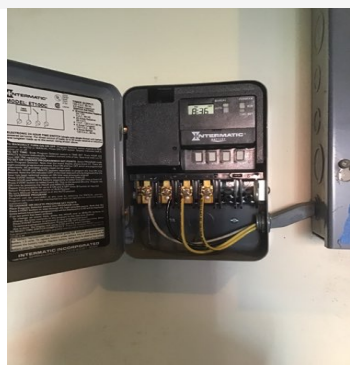
Location	Item	Results	Notes	Pic	Date	Fixed	Sev	HUD Pts	Adj Pts	Fix By
Mechanical/Utility Room	Conductors, Outlets, Switches	Electrical conductor is not properly insulated/enclosed		5	08/14/23 13:48 TK		LT	2.87	1.21 <sup>3</sup>	24H
Mechanical/Utility Room	Conductors, Outlets, Switches	Electrical conductor is not properly insulated/enclosed	Timer box	6	08/31/23 09:37 TK		LT	2.87	1.21 <sup>3</sup>	24H

Building E - Mechanical/Utility Room - Conductors, Outlets, Switches - Aug 31 2023 9:37AM - T Knight CAPTION: Timer box

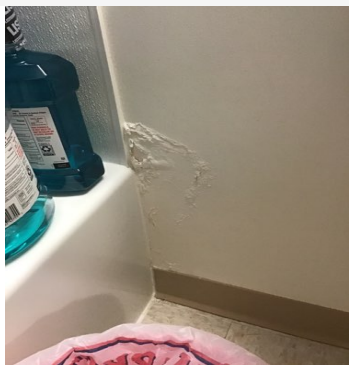
Location	Item	Results	Notes	Pic	Date	Fixed	Sev	HUD Pts	Adj Pts	Fix By
Bathroom 1	Wall Covering and Finish – Interior	Interior wall component(s) is not functionally adequate	Wall Water damage between tub and sink	Z	08/14/23 10:14 TK		Mod	0.29	0.12	30D

Building B Unit B1-9 - Bathroom 1 - Wall Covering and Finish – Interior - Aug 14 2023 10:14AM - T Knight CAPTION: Wall Water damage between tub and sink

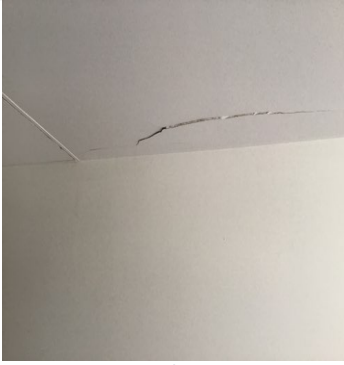
8

Location	Item	Results	Notes	Pic	Date	Fixed	Sev	HUD Pts	Adj Pts	Fix By
Bedroom 1	Ceiling Covering and Finishes	Ceiling has signs of structural failure (cracking, small circles, blisters, or nail pops)	Bedroom ceiling has large cracks	g	08/14/23 11:43 TK		Mod	0.29	0.12	30D

Building C Unit C1-20 - Bedroom 1 -  
Ceiling Covering and Finishes - Aug 14  
2023 11:43AM - T Knight CAPTION:  
Bedroom ceiling has large cracks

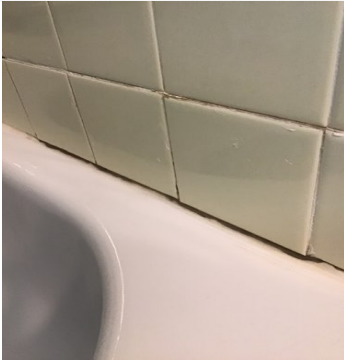
9

Location	Item	Results	Notes	Pic	Date	Fixed	Sev	HUD Pts	Adj Pts	Fix By
Bathroom 1	Mold-Like Substances	Moisture damage on a surface from 4 Sq. In. to 1 S.F.(Units)	Caulk needed between tub and wall .... Clean grout on tub walls	g	08/14/23 12:06 TK		Mod	0.29	0.12	30D

Building C Unit C2-24 - Bathroom 1 -  
Mold-Like Substances - Aug 14 2023  
12:06PM - T Knight CAPTION: Caulk  
needed between tub and wall .... Clean  
grout on tub walls

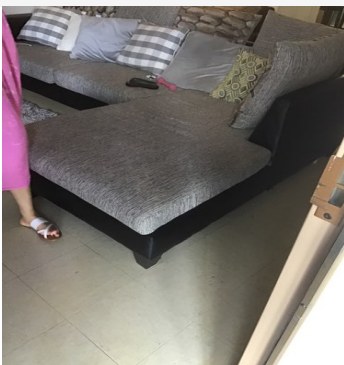
Location	Item	Results	Notes	Pic	Date	Fixed	Sev	HUD Pts	Adj Pts	Fix By
Entry Door	Egress	Obstructed means of egress at a Unit's Entry Door	It would be difficult to get a gurney into unit ....tenant will re arrange furniture	10	08/14/23 13:26 TK		LT	3.16	1.33	24H
Kitchen	Light Fixtures (Interior)	A permanently installed light fixture is inoperable	Light is out over counter in corner		08/14/23 13:30 TK		Mod	0.29	0.12	30D

Building D Unit D2-29 - Entry Door -  
Egress - Aug 14 2023 1:26PM - T Knight  
CAPTION: It would be difficult to get a  
gurney into unit ....tenant will re arrange  
furniture

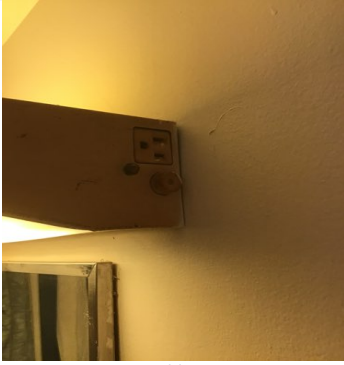
11

Location	Item	Results	Notes	Pic	Date	Fixed	Sev	HUD Pts	Adj Pts	Fix By
Bathroom 1	GFCI/AFCI	Missing GFCI protection on outlet within Six Feet of water source	Light over sink	<u>11</u>	08/31/23 15:23 TK		Severe	0.00	0.00 <sup>2</sup>	24H
Living Room	Smoke Alarms	Smoke Alarm is obstructed	Living room smoke detector missing	<u>12</u>	08/31/23 15:22 TK		LT	0.00	0.00 <sup>1</sup>	24H

Building E Unit E2-37 - Bathroom 1 - GFCI/AFCI - Aug 31 2023 3:23PM - T Knight CAPTION: Light over sink

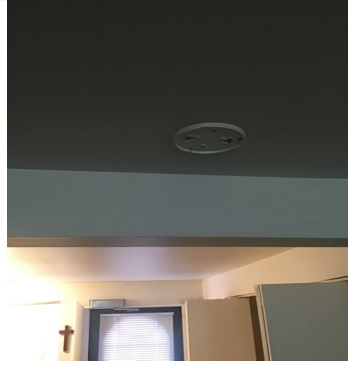
12

Building E Unit E2-37 - Living Room - Smoke Alarms - Aug 31 2023 3:22PM - T Knight CAPTION: Living room smoke detector missing

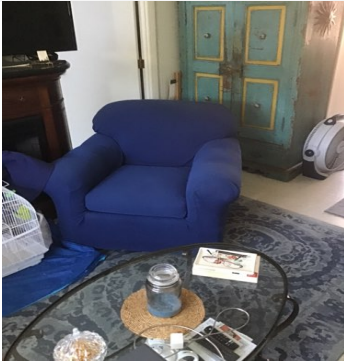
13

Location	Item	Results	Notes	Pic	Date	Fixed	Sev	HUD Pts	Adj Pts	Fix By
Alternate Location - See Notes for Details	Door Hardware - Entry (non-fire)	Entry door cannot be secured/locked	Living room door dead bolt inoperable		08/31/23 10:18 TK		Severe	0.78	0.33	24H
Living Room	Egress	The exit discharge is obstructed	Cannot get a gurney into bedroom	<u>13</u>	08/31/23 10:12 TK		LT	3.16	1.33	24H

Building E Unit E2-38 - Living Room - Egress - Aug 31 2023 10:12AM - T Knight CAPTION: Cannot get a gurney into bedroom
